Report for the Houston South Restoration Environmental Assessment

Effects to Soil and Water

Chad Menke Hydrologist
Hoosier National Forest
June, 2019

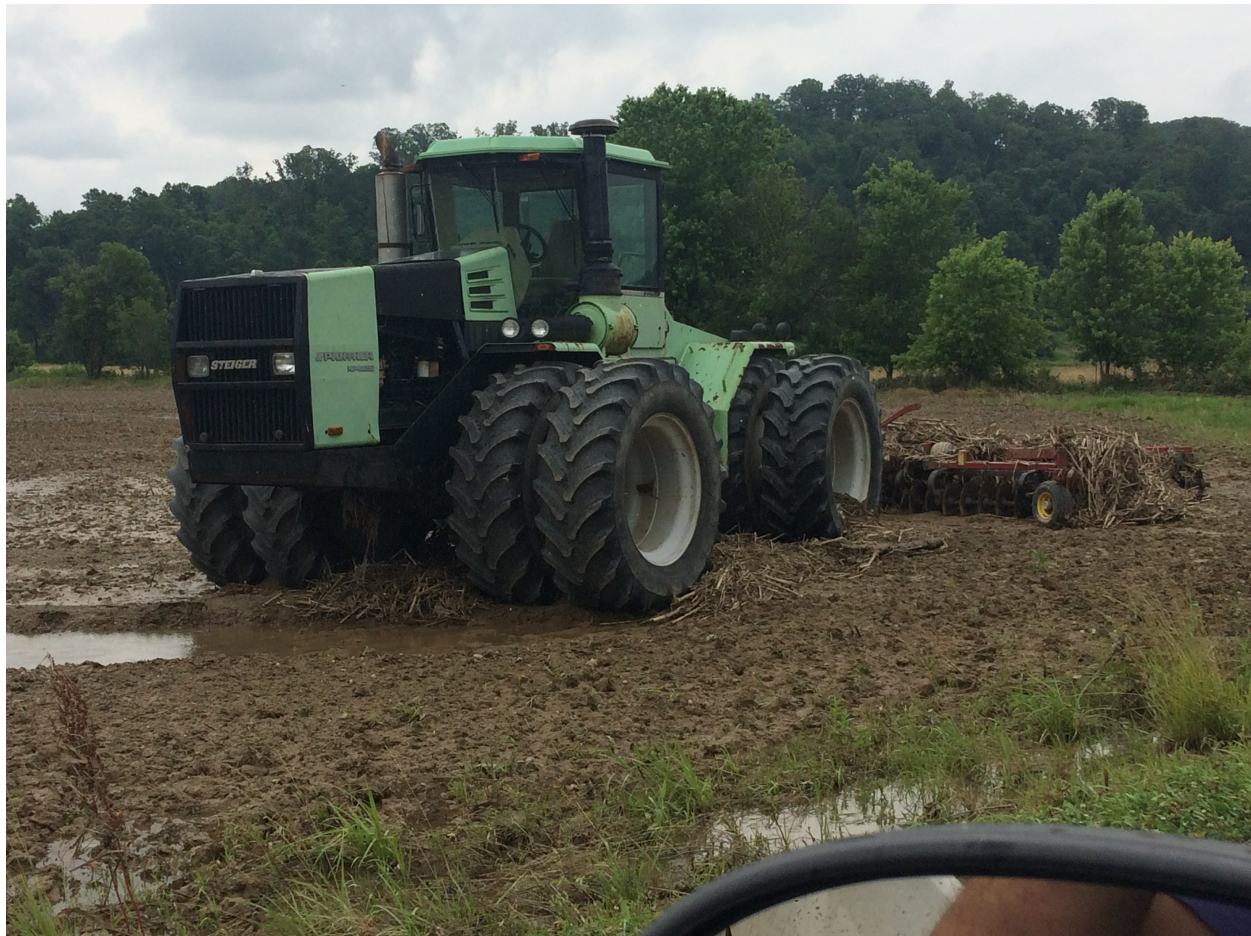
Figure 4 – Tractor surrounded by flood water debris from South Fork Salt Creek

The Forest Service is aware that activities on private land have included timber harvesting, grazing, agriculture activities, and other minor residential disturbances, all of which can reduce soil and water quality. Approximately 1,153 acres of agricultural land resides within South Fork Salt Creek watershed flood plain.

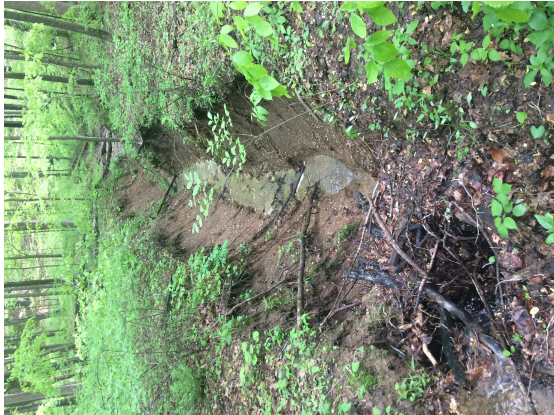
Figure 5- Head cut intermittent stream along Hickory Ridge Trail.

Some of the roads and trails will be rehabilitated with BMP measures to reduce erosion/sedimentation. There are several head cut ephemeral and intermittent streams that should be repaired using watershed restoration techniques.
